**Flood Control Project Maintenance  
Levee Inspections**  
**LMA District Cover Sheet**  
**Spring 2017 Levee Inspection Results**

**Reclamation District No. 2095 Paradise Cut**

**Spring 2017 Levee Inspection Results**

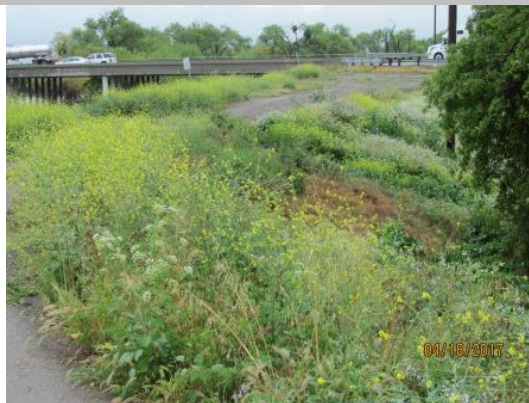
Photo 1 of 1 : SP\_2017\_RD2095\_322\_8\_20170421\_00027.jpg

View of the vegetation on the levee slope.

LM Start	0.08	Rating **	M	Issue No.	3
LM End	0.08	Issue Type +	Ma	Location *	WS
Category	Earthen Levee			GPS Latitude/Longitude	
				Start	End
Item	Slope Stability			37.770528 °	37.770528 °
				-121.326198 °	-121.326198 °
DWR ID	DWR_RD2095_01_s_2016_3				
Comment Code					
S3 : Repair the levee slope damaged by vehicle traffic and prevent access where possible.					
Inspector Comment

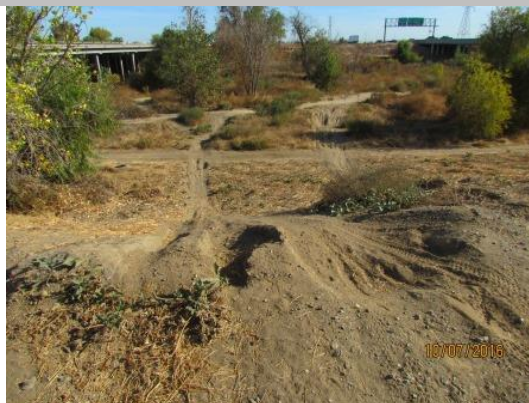
Photo 1 of 2 : SP\_2017\_RD2095\_322\_3\_20170407\_00004.jpg

Recent view of the vehicle tracks on the waterside levee slope.

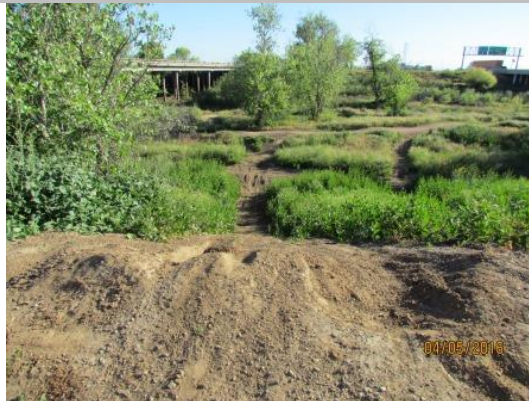
Photo 2 of 2 : SP\_2017\_RD2095\_322\_3\_20170407\_00005.jpg

View of the vehicle tracks on the waterside levee slope.

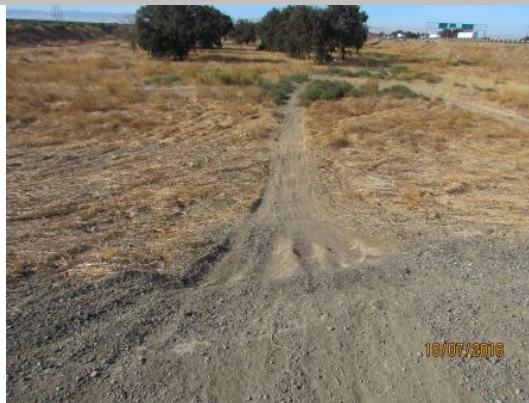
Photo 1 of 2 : SP\_2017\_RD2095\_322\_12\_20170407\_00010.jpg

LM Start	0.09	Rating **	M	Issue No.	12
LM End	0.09	Issue Type +	Ma	Location *	LS
Category	Earthen Levee			GPS Latitude/Longitude	
				Start	End
Item	Slope Stability			37.770429°	37.770429°
				-121.325986°	-121.325986°
DWR ID	DWR_RD2095_01_s_2016_12				
Comment Code					
S3 : Repair the levee slope damaged by vehicle traffic and prevent access where possible.					
Inspector Comment

Recent view of the vehicle tracks on the landside levee slope.

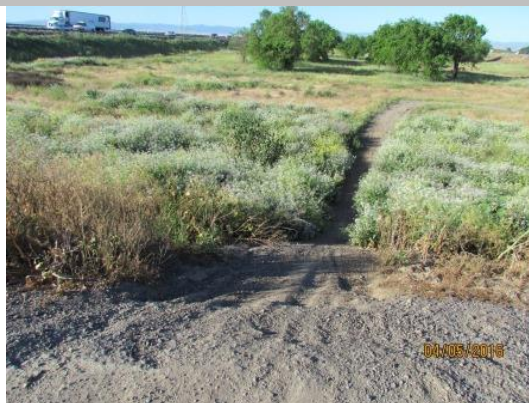
Photo 2 of 2 : SP\_2017\_RD2095\_322\_12\_20170407\_00011.jpg

View of the vehicle tracks on the landside levee slope.

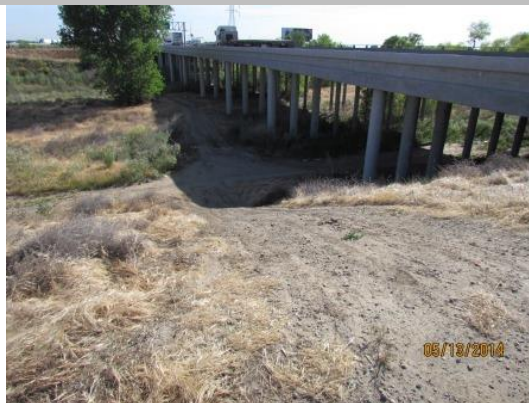
Photo 1 of 1 : SP\_2017\_RD2095\_322\_134\_20170407\_00012.jpg

LM Start	0.11	Rating **	M	Issue No.	134
LM End	0.11	Issue Type +	Ma	Location *	WS
Category	Earthen Levee			GPS Latitude/Longitude	
				Start	End
Item	Slope Stability			37.770212°	37.770212°
				-121.325675°	-121.325675°
DWR ID	DWR_RD2095_01_s_2014_134				
Comment Code					
S3 : Repair the levee slope damaged by vehicle traffic and prevent access where possible.					
Inspector Comment

View of the vehicle access on the waterside levee slope.

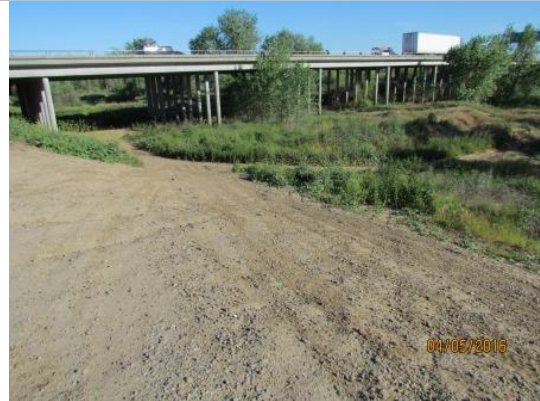
Photo 1 of 1 : SP\_2017\_RD2095\_322\_10\_20170407\_00008.jpg

LM Start	0.15	Rating **	M	Issue No.	10
LM End	0.15	Issue Type +	Ma	Location *	WS
Category	Earthen Levee			GPS Latitude/Longitude	
				Start	End
Item	Slope Stability			37.769997 °	37.769997 °
				-121.325055 °	-121.325055 °
DWR ID	DWR_RD2095_01_f_2015_10				
Comment Code					
S3 : Repair the levee slope damaged by vehicle traffic and prevent access where possible.					
Inspector Comment					
LMA is actively controlling access.

View of the vehicle tracks on the waterside levee slope.

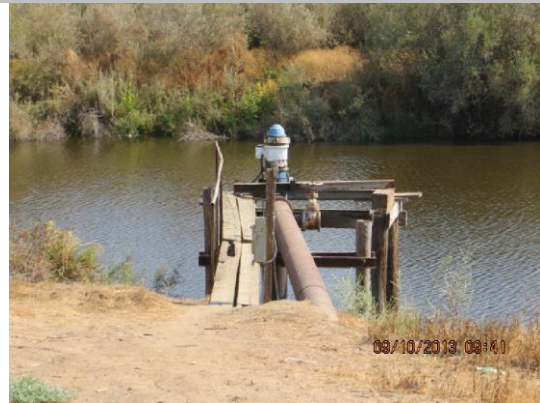
Photo 1 of 2 : UCIP\_SP\_2017\_19787\_33688.jpg

Comment Code					
Inspector Comment					
FS_ID:19787 DS_ID:21635 EP_NO: N/A Repair Type: Non-Urgent Crossing Status: Found UCIP Comments: Wooden walkway to pier possible safety hazard as wood planks are rotten. Positive closure device missing from distribution box on LS toe. FIELD_STRUCT_DESC: 16-inch steel irrigation pipe through the levee 8.0 feet below the crown. Pump on pile structure in the channel. 5'X5' concrete distribution box at the toe of the landward slope. Originally included in the 1964 O&M manual. Permit 18886 (2014) requested to authorize the pump station, pipe and distribution box as part of the construction of a new pipe using the same platform and distribution box. FS Date: 9/10/2013

Pump on pier on WS toe.

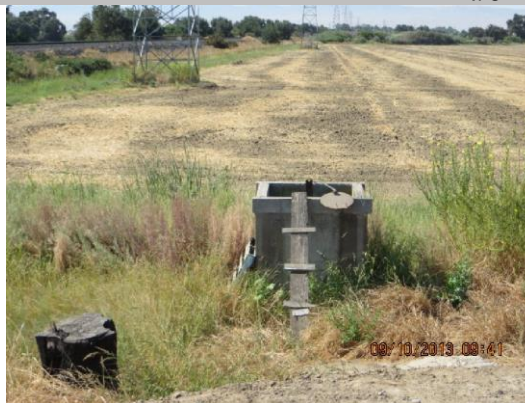
Photo 2 of 2 : UCIP\_SP\_2017\_19787\_33687.jpg

Item	DWR UCIP Field Study			37.763859 °		37.763859 °
				-121.319096 °		-121.319096 °
DWR ID						
Comment Code						
Inspector Comment						
FS_ID:19787						
DS_ID:21635						
EP_NO: N/A						
Repair Type: Non-Urgent						
Crossing Status: Found						
UCIP Comments: Wooden walkway to pier possible safety hazard as wood planks are rotten. Positive closure device missing from distribution box on LS toe.						
FIELD_STRUCT_DESC: 16-inch steel irrigation pipe through the levee 8.0 feet below the crown. Pump on pile structure in the channel. 5'X5' concrete distribution box at the toe of the landward slope. Originally included in the 1964 O&M manual. Permit 18886 (2014) requested to authorize the pump station, pipe and distribution box as part of the construction of a new pipe using the same platform and distribution box.						
FS Date: 9/10/2013

Concrete distribution box on LS toe.

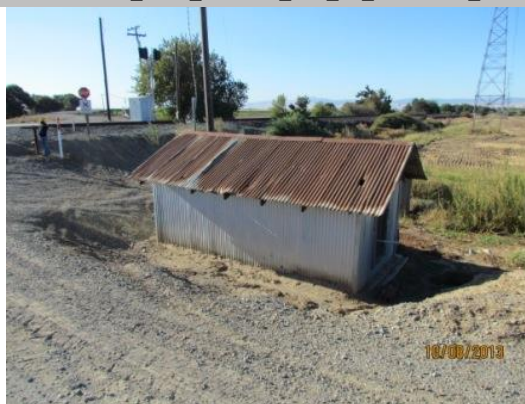
Photo 1 of 1 : SP\_2017\_RD2095\_322\_11\_20170407\_00009.jpg

LM Start	0.71	Rating **	M	Issue No.	11
LM End	0.71	Issue Type +	En	Location *	LS
Category	Earthen Levee			GPS Latitude/Longitude	
				Start	End
Item	Encroachments			37.763630 °	37.763630 °
				-121.319045 °	-121.319045 °
DWR ID	DWR_RD2095_01_s_2012_11				
Comment Code					
BU : Building					
Inspector Comment					
Pump house near RR.

View of building at the landside levee toe.

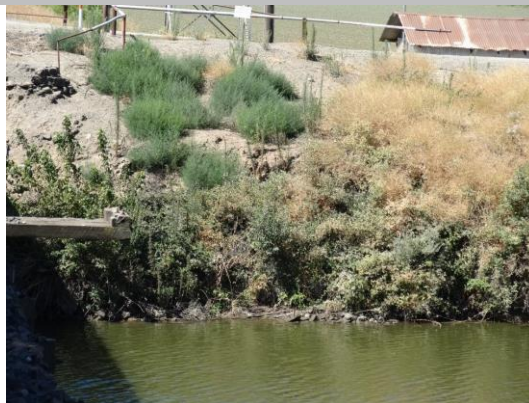
Photo 1 of 3 : SP\_2017\_RD2095\_322\_1\_20170407\_00001.jpg

Comment Code					
Inspector Comment					
07/20/2016: No significant change observed.					
08/04/2015: No significant change observed.					
08/26/2014: No significant change observed.					
08/28/2013: No significant change observed.					
07/18/2012: No significant change observed.					
09/02/2011: No significant change observed.					
09/22/2010: No significant change observed. There is now considerable vegetation at the water line and along the lower berm slope. However, the erosion on the lower berm slope is still present and has not been corrected.					
08/06/2010: Recommended for local maintenance issue, per CLRO.					
07/29/2009: No major change since last visit; noticeable vegetation growth; erosion is on berm, but if left untreated, it will eventually erode into levee prism; site is recommended for annual assessment and monitoring of the site, per CLRO CES 2008 Report; Site # is the same as RM6.80,LM0.73; previously rated "U".

07/22/2008: Downstream of WPRR near siphon pipe & pump; sandy levee; visited by Jeff Van Gilder and LRO in 2008 for repair assessment; scouring downstream of RR crossing, possibly caused by eddy effects.					
03/13/2007: Site visited on 03/13/2007. [2016 Site ID:RD2095U01RM6.74]

Looking at the erosion from the RR bridge.

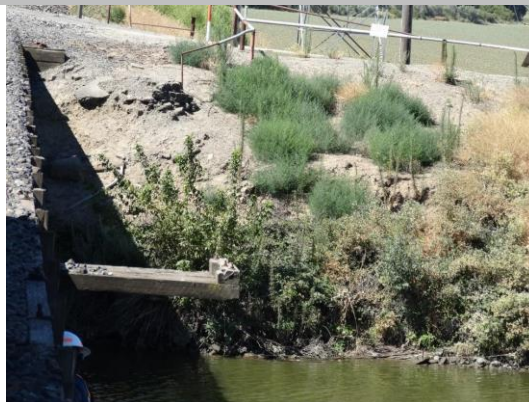
Photo 2 of 3 : SP\_2017\_RD2095\_322\_1\_20170407\_00002.jpg

Looking down at the erosion downstream of the RR bridge.

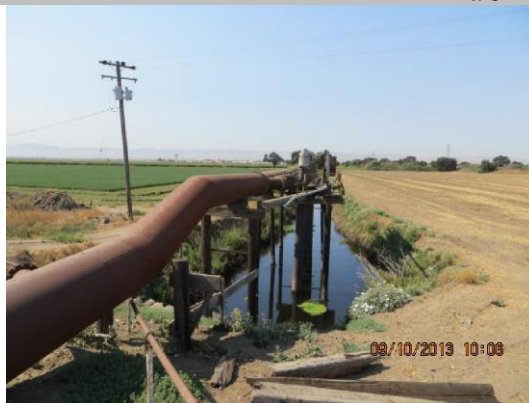
Photo 1 of 3 : UCIP\_SP\_2017\_19812\_33711.jpg

LM Start	0.87	Rating **	M	Issue No.	136
LM End	0.87	Issue Type +	En	Location *	WS
Category	Supplemental			GPS Latitude/Longitude	
				Start	End
Item	DWR UCIP Field Study			37.761582 °	37.761582 °
				-121.317881 °	-121.317881 °
DWR ID					
Comment Code					
Inspector Comment					
FS_ID:19812 DS_ID:21637 EP_NO: 13926 Repair Type: Non-Urgent Crossing Status: Found UCIP Comments: No electrical connection can be identified. Possibly awaiting a flood event for re-activation. FIELD_STRUCT_DESC: 40-inch steel stormdrain discharge pipe through the levee 1-foot below the crown. 6 pumps mounted on wooden pier at LS toe, all discharge into 40-inch pipe. Permit was for a 24-inch steel discharge pipe through levee 2.0 feet below crown with a flapgate on waterward side. But, Permit notes show it was modified in 2001 to its current status (Permit No. 13926). FS Date: 9/10/2013

Pumps on pier at LS toe. Note electrical conduit without connection on right side of pier.

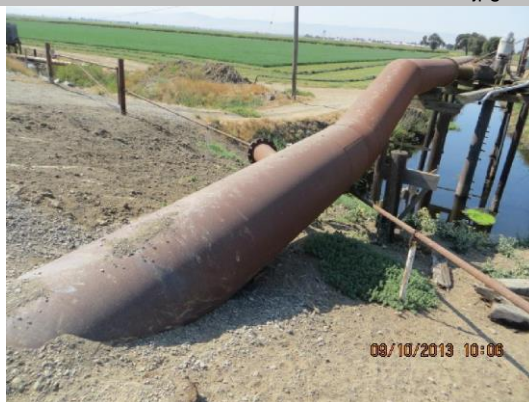
Photo 2 of 3 : UCIP\_SP\_2017\_19812\_33710.jpg

Pipe on LS slope.

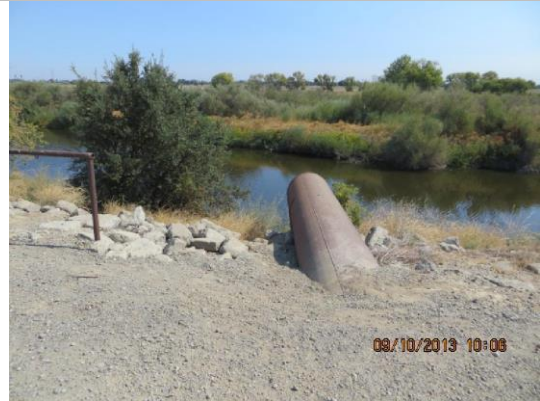
Photo 3 of 3 : UCIP\_SP\_2017\_19812\_33709.jpg

Pipe on WS shoulder.

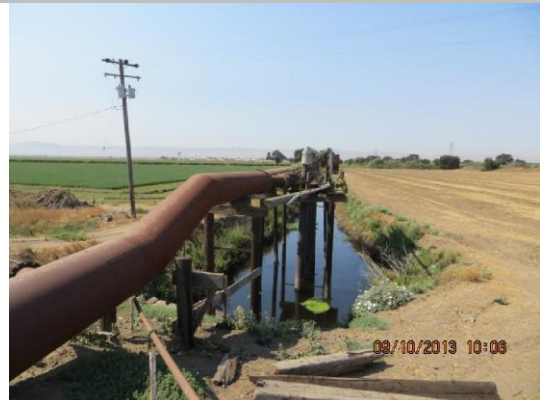
Photo 1 of 3 : UCIP\_SP\_2017\_34387\_62273.jpg

LM Start	0.87	Rating **	M	Issue No.	137
LM End	0.87	Issue Type +	En	Location *	WS
Category	Supplemental			GPS Latitude/Longitude	
				Start	End
Item	DWR UCIP Field Study			37.761554 °	37.761554 °
				-121.317847 °	-121.317847 °
DWR ID					
Comment Code					
Inspector Comment					
FS_ID:34387 DS_ID:21629 EP_NO: 6259 Repair Type: Non-Urgent Crossing Status: Found UCIP Comments: What appears to be the concrete headwall on the LS toe is tilting and failing. There is a possibility that the concrete is rubble used to fill in around levee toe. Good candidate for video inspection. FIELD_STRUCT_DESC: 30-inch corrugated metal pipe through levee 21.0 feet below crown. Slide gate in riser on the waterward slope. Concrete headwalls and aprons on both ends. Flap gate on the waterward end. Two corrugated metal cutoff walls ( Permit No. 6259, 1969). FS Date: 9/10/2013

Pipe inlet located below 40-inch pipe at LS toe canal.

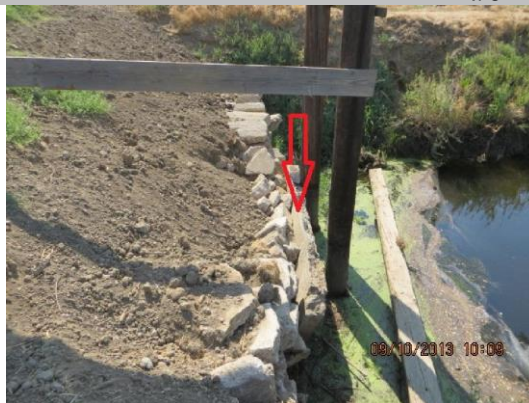
Photo 2 of 3 : UCIP\_SP\_2017\_34387\_62272.jpg

Item	DWR UCIP Field Study			37.761554 °		37.761554 °
				-121.317847 °		-121.317847 °
DWR ID						
Comment Code						
Inspector Comment						
FS_ID:34387						
DS_ID:21629						
EP_NO: 6259						
Repair Type: Non-Urgent						
Crossing Status: Found						
UCIP Comments: What appears to be the concrete headwall on the LS toe is tilting and failing. There is a possibility that the concrete is rubble used to fill in around levee toe. Good candidate for video inspection.						
FIELD_STRUCT_DESC: 30-inch corrugated metal pipe through levee 21.0 feet below crown. Slide gate in riser on the waterward slope.						
Concrete headwalls and aprons on both ends. Flap gate on the waterward end. Two corrugated metal cutoff walls ( Permit No. 6259, 1969).						
FS Date: 9/10/2013

Concrete headwall on LS toe is tilting heavily towards canal.

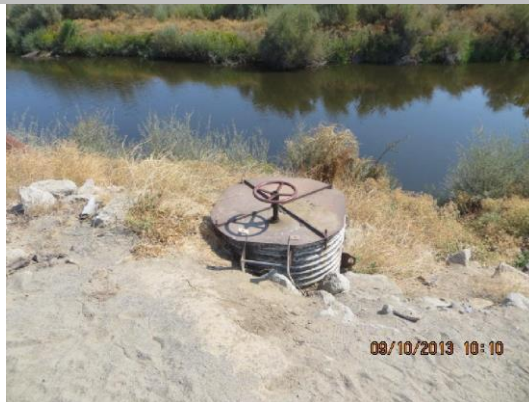
Photo 3 of 3 : UCIP\_SP\_2017\_34387\_62271.jpg

Slide gate in 48-inch CMP riser on WS shoulder.

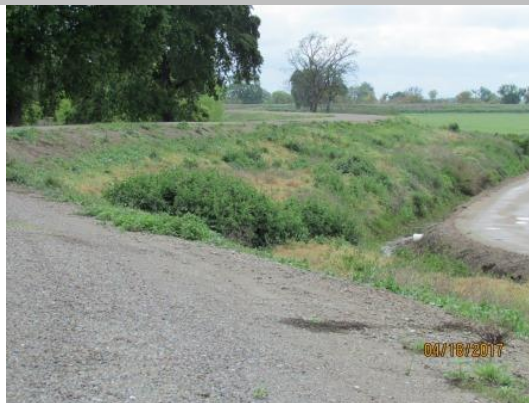
Photo 1 of 1 : SP\_2017\_RD2095\_322\_9\_20170421\_00028.jpg

View of the vegetation on the landside levee slope and toe.

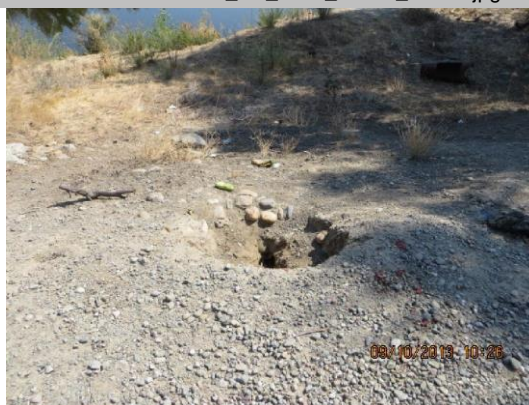
Photo 1 of 3 : UCIP\_SP\_2017\_19815\_33719.jpg

LM Start	0.91	Rating **	M	Issue No.	138
LM End	0.91	Issue Type +	En	Location *	LS
Category	Supplemental			GPS Latitude/Longitude	
				Start	End
Item	DWR UCIP Field Study			37.761079 °	37.761079 °
				-121.317567 °	-121.317567 °
DWR ID					
Comment Code					
Inspector Comment					
FS_ID:19815 DS_ID:21630 EP_NO: N/A Repair Type: Non-Urgent Crossing Status: Indicator Found UCIP Comments: Pipe abandoned and should be verified as having been done so properly. FIELD_STRUCT_DESC: *ABANDONED* 12-inch steel stormdrain pipe through the levee 1.5 feet below the crown. Pump on pile structure in drain ditch on landward side. Siphon breaker in steel standpipe on the waterward slope. Originally included in the 1964 O&M manual. FS Date: 9/10/2013

Hole on LS shoulder where standpipe may have been located.

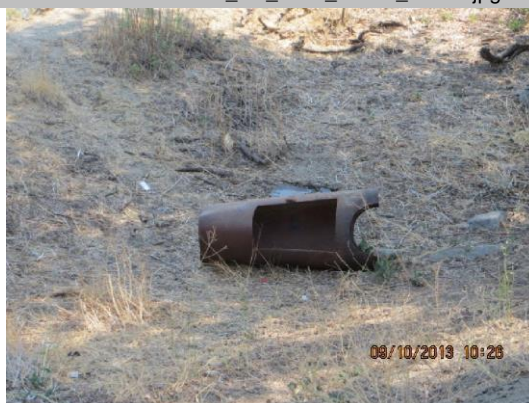
Photo 2 of 3 : UCIP\_SP\_2017\_19815\_33718.jpg

Standpipe discarded on WS berm.

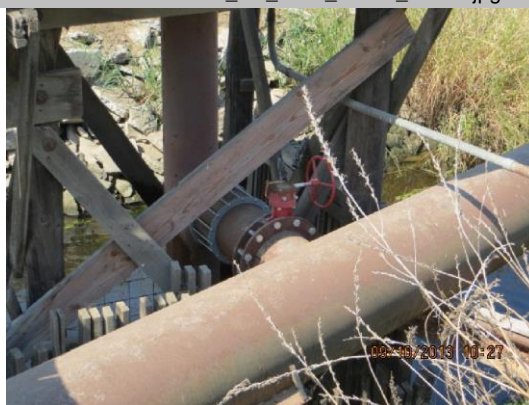
Photo 3 of 3 : UCIP\_SP\_2017\_19815\_33717.jpg

Possible location of 12-inch pipe connection to pump on LS toe.

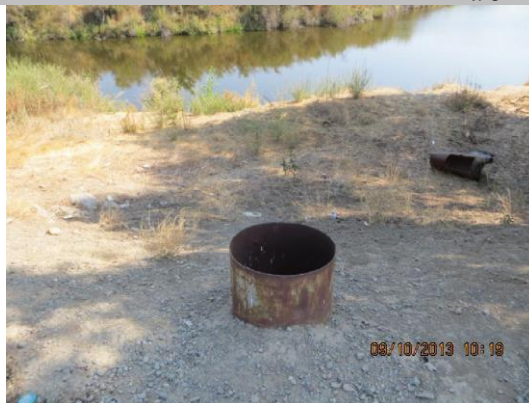
Photo 1 of 3 : UCIP\_SP\_2017\_19813\_33715.jpg

LM Start	0.91	Rating **	M	Issue No.	139
LM End	0.91	Issue Type +	En	Location *	LS
Category	Supplemental			GPS Latitude/Longitude	
				Start	End
Item	DWR UCIP Field Study			37.761046 °	37.761046 °
				-121.317540 °	-121.317540 °
DWR ID					
Comment Code					
Inspector Comment					
FS_ID:19813 DS_ID:21631 EP_NO: 6537 Repair Type: Non-Urgent Crossing Status: Found UCIP Comments: Corroded holes on pipe at outlet WS toe, good indication of internal pipe condition. Good candidate for video inspection. FIELD_STRUCT_DESC: 14-inch steel stormdrain discharge pipe through the levee 2.5 feet below the crown. Pump on pile structure in drain ditch on landward side. Siphon breaker in 24-inch CMP riser on the waterward shoulder and flap gate on the waterward end (Permit No. 6537, 1969). FS Date: 9/10/2013

Siphon Breaker/vent in 24-inch steel riser on WS shoulder.

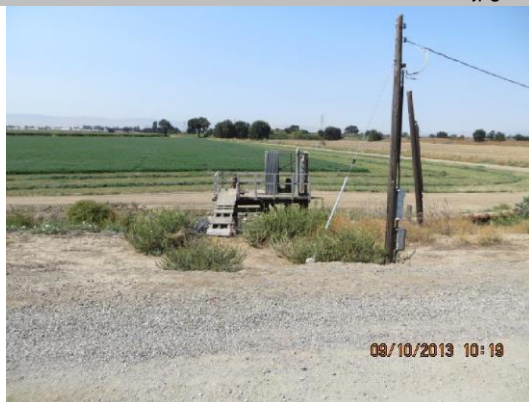
Photo 2 of 3 : UCIP\_SP\_2017\_19813\_33714.jpg

Pump on wooden pier at LS toe.

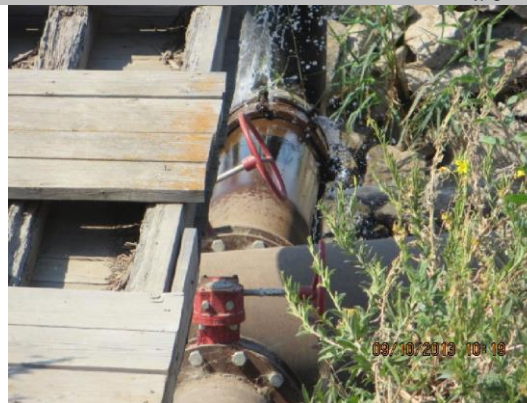
Photo 3 of 3 : UCIP\_SP\_2017\_19813\_33713.jpg

Butterfly valve at pump on LS toe.

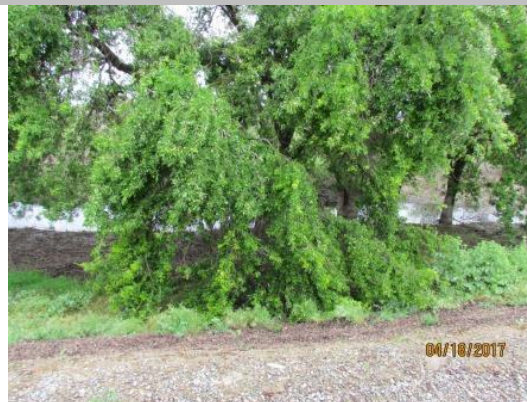
Photo 1 of 1 : SP\_2017\_RD2095\_322\_13\_20170421\_00029.jpg

LM Start	1.27	Rating **	M	Issue No.	13
LM End	1.27	Issue Type +	Ma	Location *	WS
Category	Earthen Levee			GPS Latitude/Longitude	
				Start	End
Item	Trim / Thin Trees			37.759477 °	37.759477 °
				-121.311564 °	-121.311564 °
DWR ID	DWR_RD2095_01_s_2017_13				
Comment Code					
T1 : Trim trees to at least five feet above ground level.					
Inspector Comment

View of the tree limbs that need to be trimmed.

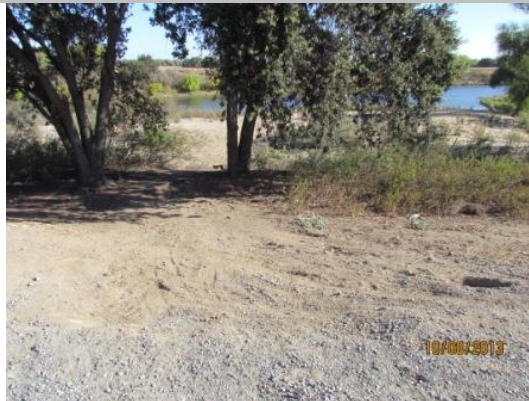
Photo 1 of 1 : SP\_2017\_RD2095\_323\_9\_20170407\_00008.jpg

LM Start	0.03	Rating **	A/W	Issue No.	9
LM End	0.03	Issue Type +	Ma	Location *	WS
Category	Earthen Levee			GPS Latitude/Longitude	
				Start	End
Item	Slope Stability			37.758986 °	37.758986 °
				-121.307854 °	-121.307854 °
DWR ID	DWR_RD2095_02_s_2013_9				
Comment Code					
S3 : Repair the levee slope damaged by vehicle traffic and prevent access where possible.					
Inspector Comment

View of the vehicle tire ruts on waterside levee slope.

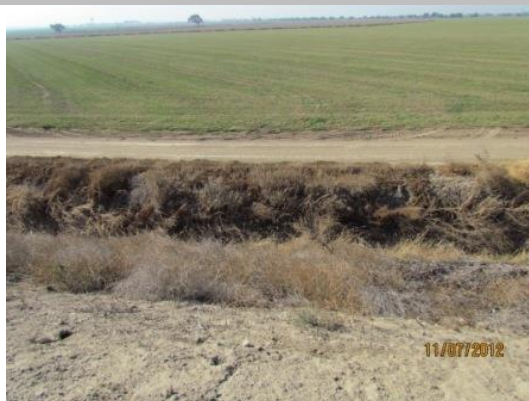
Photo 1 of 1 : SP\_2017\_RD2095\_323\_5\_20170407\_00007.jpg

View of a ditch along the landside toe.

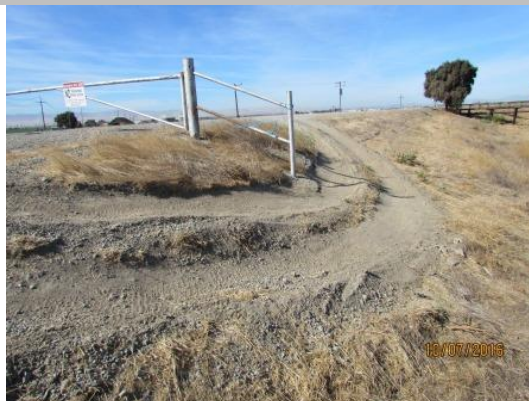
Photo 1 of 2 : SP\_2017\_RD2095\_323\_11\_20170407\_00009.jpg

LM Start	0.82	Rating **	M	Issue No.	11
LM End	0.82	Issue Type +	Ma	Location *	WS
Category	Earthen Levee			GPS Latitude/Longitude	
				Start	End
Item	Slope Stability			37.749644 °	37.749644 °
				-121.301960 °	-121.301960 °
DWR ID	DWR_RD2095_02_s_2016_11				
Comment Code					
S3 : Repair the levee slope damaged by vehicle traffic and prevent access where possible.					
Inspector Comment

Recent view of the vehicle tracks on the waterside levee slope, facing downstream.

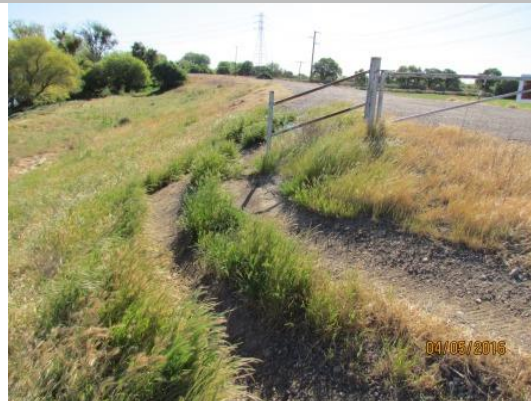
Photo 2 of 2 : SP\_2017\_RD2095\_323\_11\_20170407\_00010.jpg

View of the vehicle tracks on the waterside levee slope.

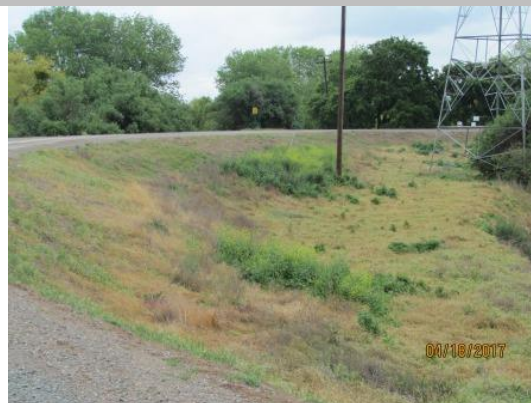
Photo 1 of 1 : SP\_2017\_RD2095\_323\_18\_20170421\_00029.jpg

View of the vegetation on the landside levee slope.

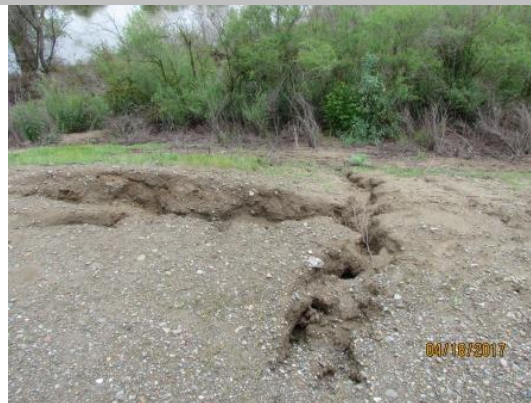
Photo 1 of 1 : SP\_2017\_RD2095\_323\_22\_20170421\_00030.jpg

LM Start	0.94	Rating **	M	Issue No.	22
LM End	0.94	Issue Type +	Ma	Location *	WS
Category	Earthen Levee			GPS Latitude/Longitude	
				Start	End
Item	Erosion / Bank Caving			37.749840 °	37.749840 °
				-121.299705 °	-121.299705 °
DWR ID	DWR_RD2095_02_s_2017_22				
Comment Code					
E2 : Schedule repair of erosion site prior to the next inspection.					
Inspector Comment

View of the erosion on the levee slope.

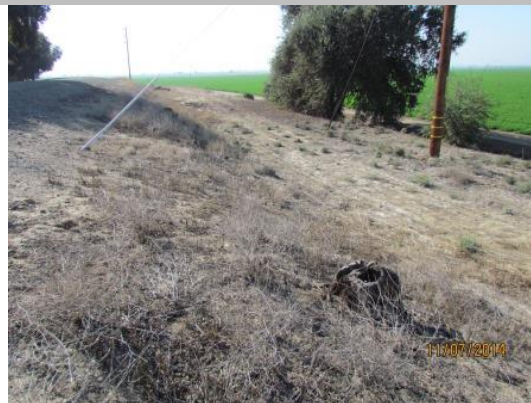
Photo 1 of 1 : SP\_2017\_RD2095\_323\_3\_20170407\_00006.jpg

View of the tree stumps on the landside levee slope..

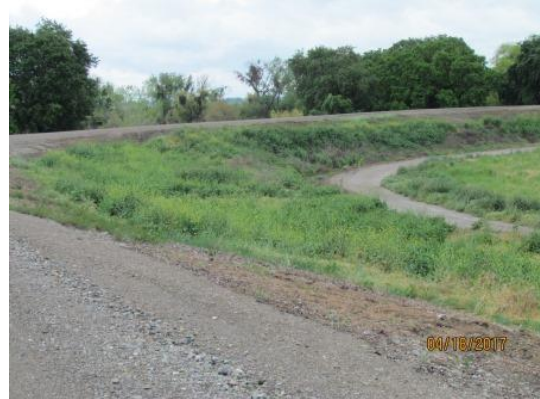
Photo 1 of 1 : SP\_2017\_RD2095\_323\_23\_20170421\_00031.jpg

View of the vegetation on the landside levee slope.

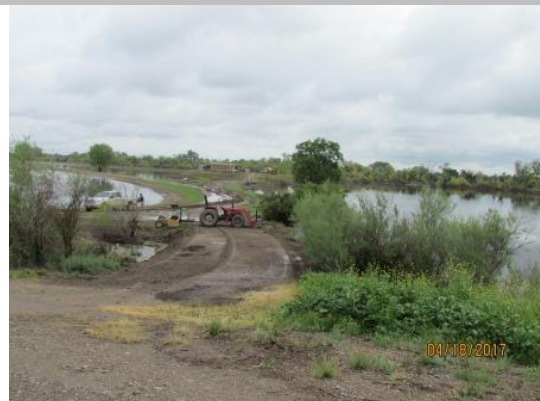
Photo 1 of 2 : SP\_2017\_RD2095\_323\_17\_20170421\_00033.jpg

The road and fence washed out during high water. Landowner is installing the gate back further away from the levee. Spring 2017.

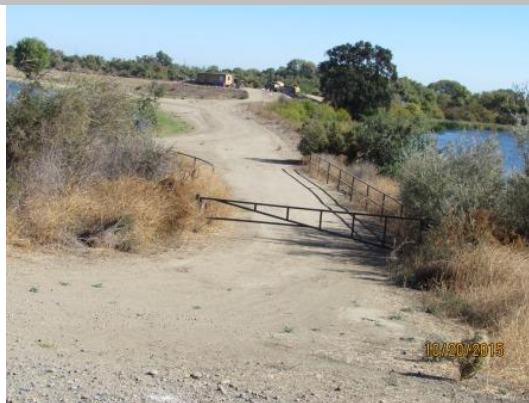
Photo 2 of 2 : SP\_2017\_RD2095\_323\_17\_20170407\_00012.jpg

View of the gate and fence in the floodway at the waterside levee toe.

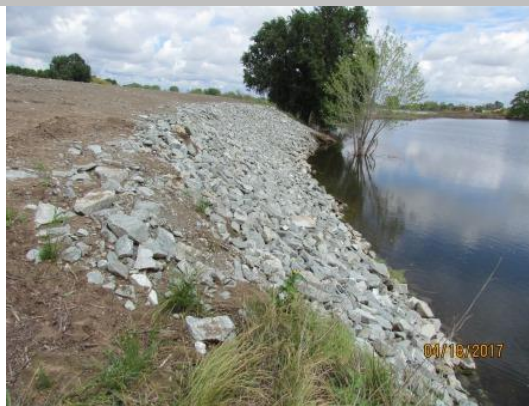
Photo 1 of 2 : SP\_2017\_RD2095\_323\_195\_20170421\_00032.jpg

LM Start	1.35	Rating **	A/W	Issue No.	195
LM End	1.35	Issue Type +	Ma	Location *	WS
Category	Earthen Levee			GPS Latitude/Longitude	
				Start	End
Item	Erosion / Bank Caving			37.744746 °	37.744746 °
				-121.297695 °	-121.297695 °
DWR ID	DWR_RD2095_02_s_2014_195				
Comment Code					
E1 : Note and monitor erosion site.					
Inspector Comment					
Erosion site repaired February 2017.

View of the repaired erosion site. Spring 2017.

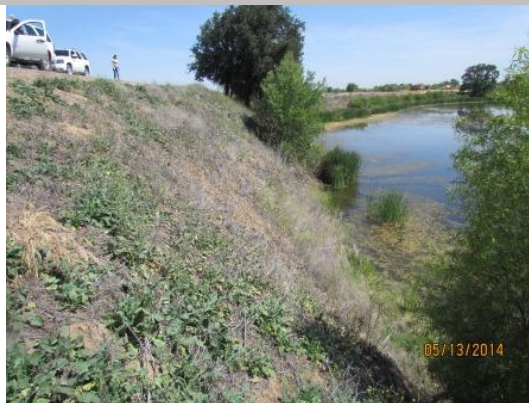
Photo 2 of 2 : SP\_2017\_RD2095\_323\_195\_20170407\_00018.jpg

View of the erosion on the waterside levee slope possibly eroding into the levee prism.

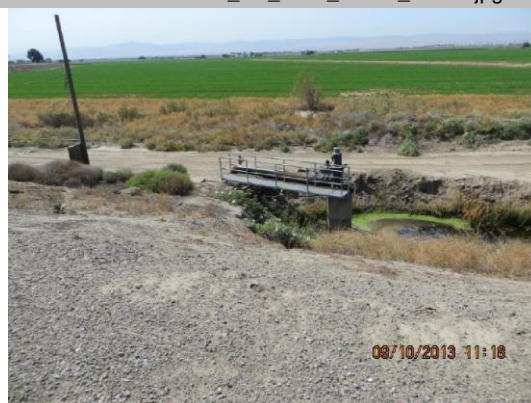
Photo 1 of 1 : UCIP\_SP\_2017\_19863\_33760.jpg

LM Start	1.48	Rating **	M	Issue No.	942
LM End	1.48	Issue Type +	Ma	Location *	WS
Category	Supplemental			GPS Latitude/Longitude	
				Start	End
Item	DWR UCIP LMA Responsibility			37.743142 °	37.743142 °
				-121.297692 °	-121.297692 °
DWR ID					
Comment Code					
Inspector Comment					
FS_ID:19863					
DS_ID:21642					
EP_NO: 4658					
Repair Type: Non-Urgent					
Crossing Status: Found					
UCIP Comments: Pipe appears abandoned in place and re-routed to LM 1.652. Need to verify pipe was properly abandoned. Permit FIELD_STRUCT_DESC: *ABANDONED* 14-inch pipe through levee 3.5-feet below crown. Pump on structure over drain ditch on the landward side. Flap gate on the waterward end (Permit No. 4658). Originally included in the 1968 O&M manual.					
FS Date: 9/10/2013

Pump visible on LS toe, but pipe has been re-routed to southwest.

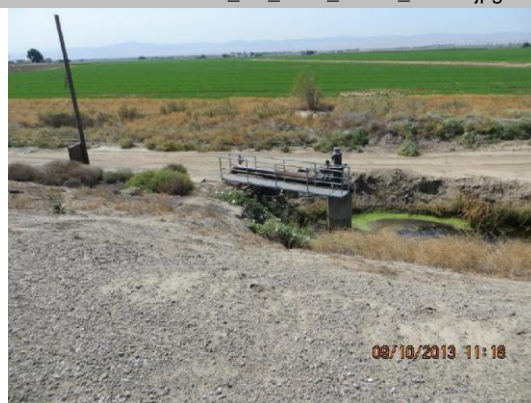
Photo 1 of 3 : UCIP\_SP\_2017\_19866\_33767.jpg

LM Start	1.63	Rating **	M	Issue No.	943
LM End	1.63	Issue Type +	En	Location *	WS
Category	Supplemental			GPS Latitude/Longitude	
				Start	End
Item	DWR UCIP Field Study			37.741345 °	37.741345 °
				-121.296189 °	-121.296189 °
DWR ID					
Comment Code					
Inspector Comment					
FS_ID:19866 DS_ID:21654 EP_NO: 6298A Repair Type: Non-Urgent Crossing Status: Found UCIP Comments: No permit identified for this crossing. FIELD_STRUCT_DESC: 16-inch steel stormdrain pipe through the levee 2-feet below the crown. Siphon breaker in PVC riser on WS shoulder. Pump on pier in ditch on LS toe 750-feet to Northwest from crossing. FS Date: 9/10/2013

Pump located at levee toe 750-feet north west of pipe crossing.

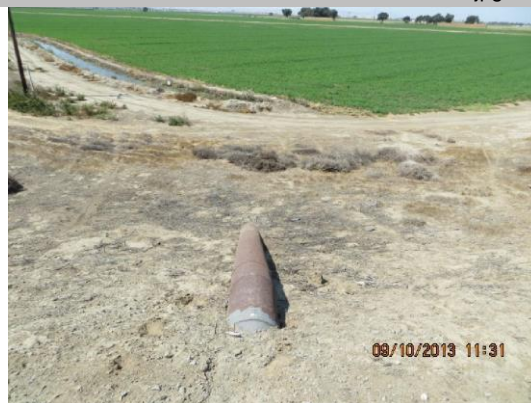
Photo 2 of 3 : UCIP\_SP\_2017\_19866\_33766.jpg

16-inch steel pipe on LS slope.

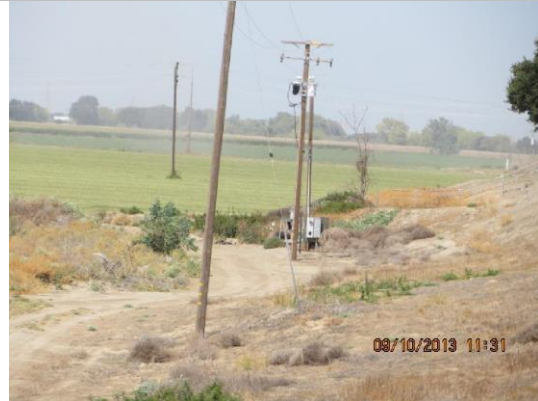
Photo 3 of 3 : UCIP\_SP\_2017\_19866\_33765.jpg

Pump located at levee toe 750-feet north west of pipe crossing.

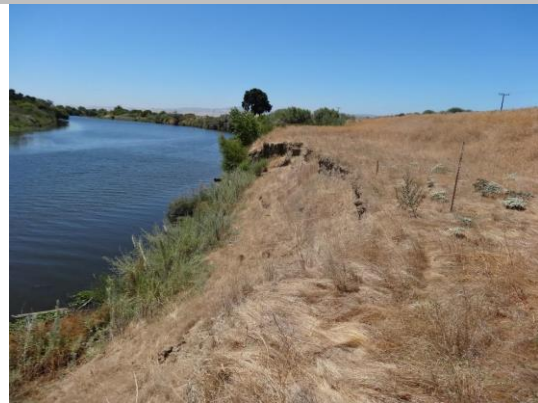
Photo 1 of 3 : SP\_2017\_RD2095\_323\_1\_20170407\_00001.jpg

Looking at the erosion from downstream of the site.

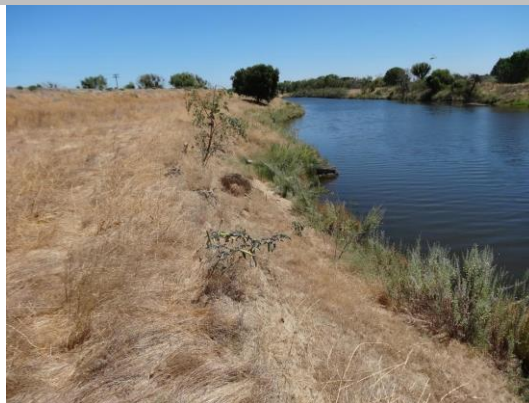
Photo 2 of 3 : SP\_2017\_RD2095\_323\_1\_20170407\_00002.jpg

Looking at the erosion from upstream of the site

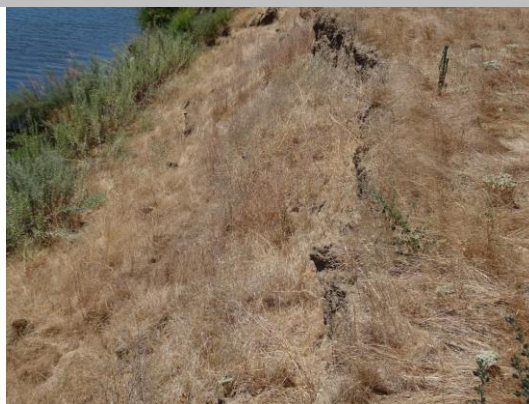
Photo 3 of 3 : SP\_2017\_RD2095\_323\_1\_20170407\_00003.jpg

Close view of the site.

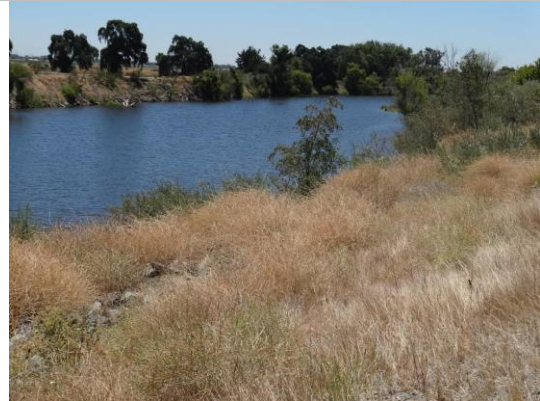
Photo 2 of 2 : SP\_2017\_RD2095\_323\_2\_20170407\_00005.jpg

The erosion is not visible from the levee top. The levee slope is protected by riprap rocks.

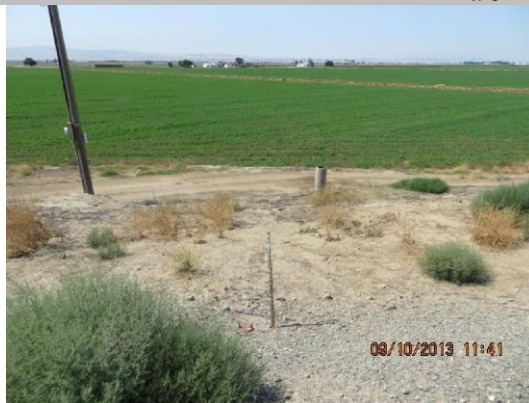
Photo 1 of 3 : UCIP\_SP\_2017\_19867\_33771.jpg

Siphon breaker on LS shoulder next to T-post with Power pole and concrete standpipe on LS toe.

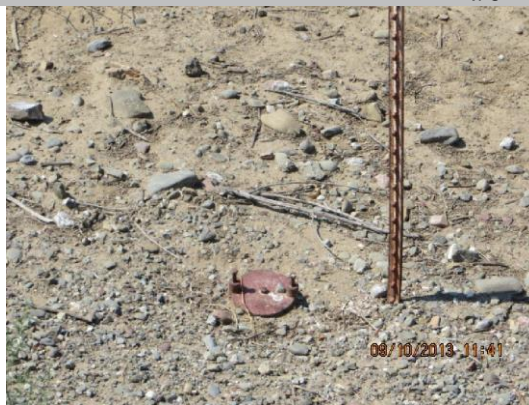
Photo 2 of 3 : UCIP\_SP\_2017\_19867\_33770.jpg

Siphon breaker on LS shoulder next to T-post.

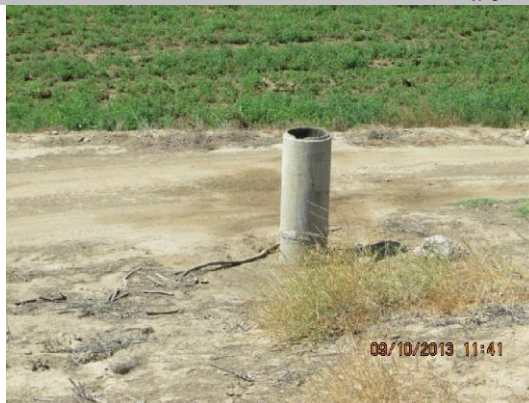
Photo 3 of 3 : UCIP\_SP\_2017\_19867\_33769.jpg

Concrete standpipe on LS toe.

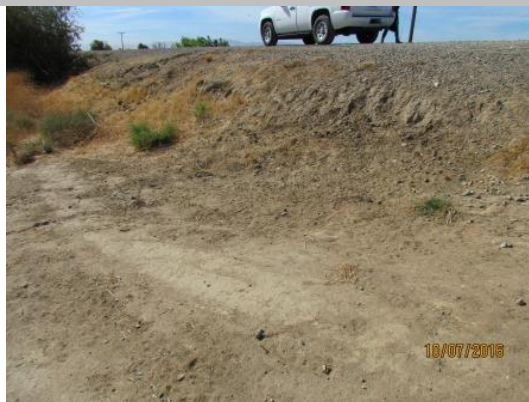
Photo 1 of 2 : SP\_2017\_RD2095\_323\_19\_20170407\_00014.jpg

View of the erosion on the waterside levee slope.

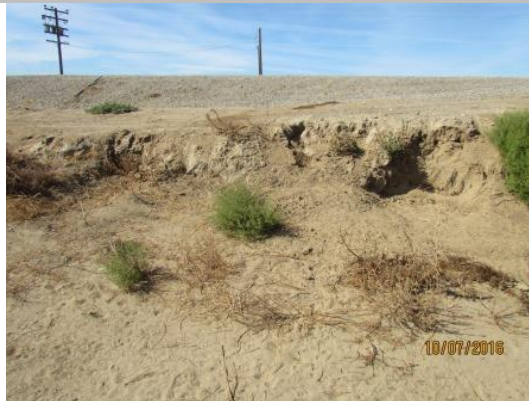
Photo 2 of 2 : SP\_2017\_RD2095\_323\_19\_20170407\_00015.jpg

View of the erosion caused by excavation on the waterside levee slope.

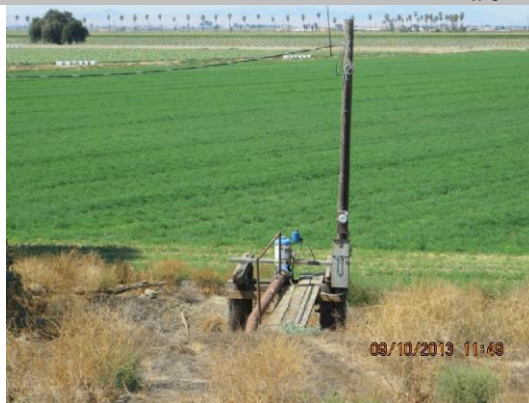
Photo 1 of 2 : UCIP\_SP\_2017\_19871\_33778.jpg

Pump on metal pier off LS toe.

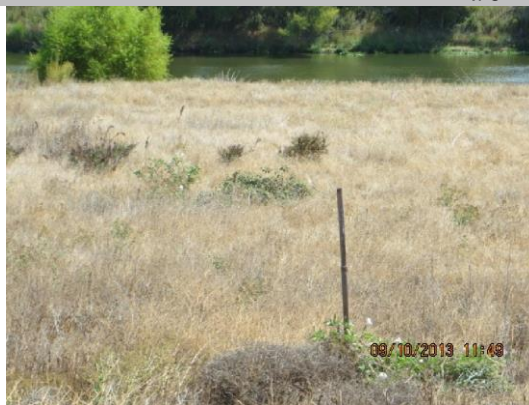
Photo 2 of 2 : UCIP\_SP\_2017\_19871\_33777.jpg

Vent standpipe on WS toe.

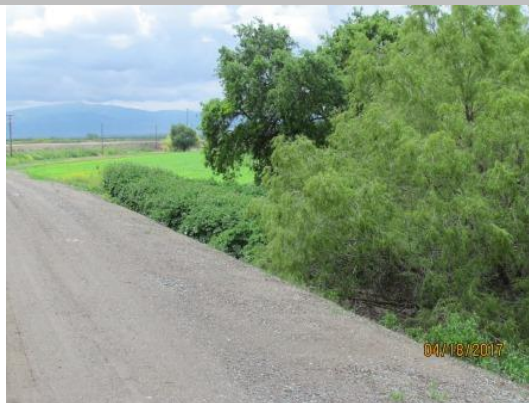
Photo 1 of 1 : SP\_2017\_RD2095\_323\_24\_20170421\_00034.jpg

View of the vegetation on the landside levee slope.

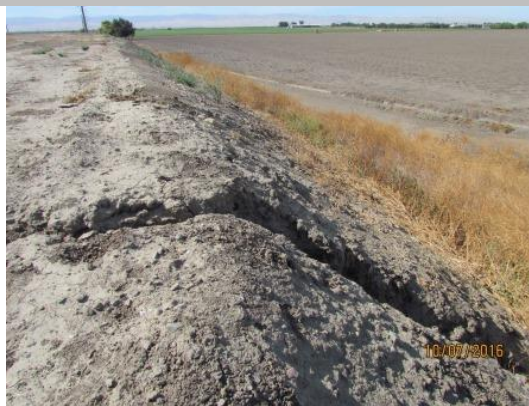
Photo 1 of 2 : SP\_2017\_RD2095\_323\_21\_20170407\_00016.jpg

View of the landside levee slope erosion.

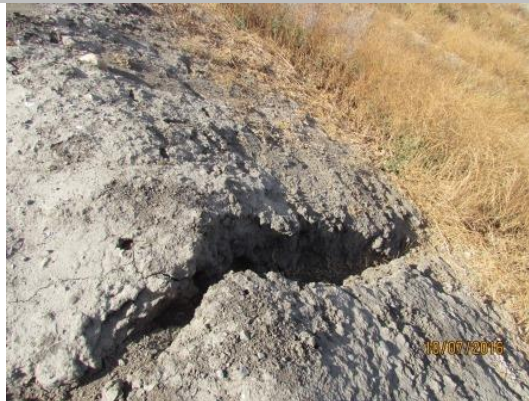
Photo 2 of 2 : SP\_2017\_RD2095\_323\_21\_20170407\_00017.jpg

Another view of the landside levee slope erosion.
